# ASBESTOS SURVEY REPORT

## **MODULAR CLASSROOM #2 SCDMH BULL STREET CAMPUS COLUMBIA, SOUTH CAROLINA**

S&ME Project No. 1614-08-330

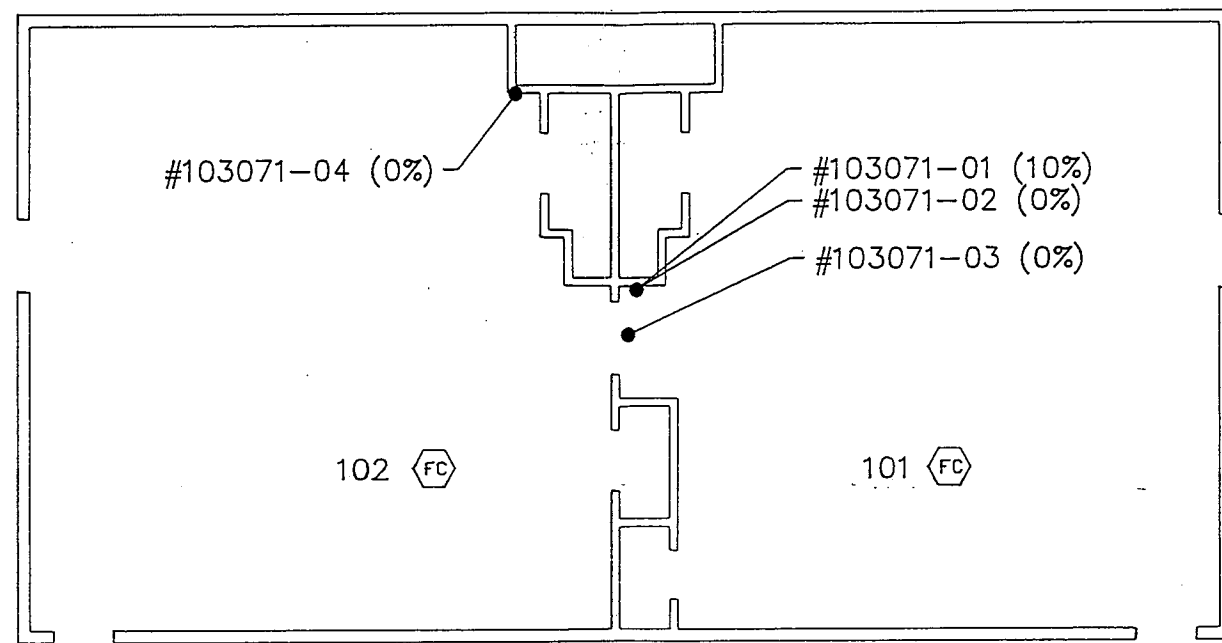
*Building Plans Showing Sample Locations and  
Areas Containing Asbestos*

Laboratory analysis of a sample of floor covering collected from Room 101 indicates 10 percent chrysotile asbestos content. The floor covering was nonfriable and in good condition. Samples of baseboard and gypsum board were also collected from the building, but were found to contain no asbestos. According to 40 CFR 763.87, the Environmental Protection Agency defines a material to qualify as "asbestos-containing material" if any sample of the suspect material from a homogeneous area is found to contain asbestos in concentrations greater than one percent.

Asbestos-containing floor covering was found throughout the building. This material was in good condition, was nonfriable, and does not present an immediate exposure hazard to building occupants. Therefore, an O&M program should be implemented to prevent the asbestos-containing floor covering from deteriorating and creating an exposure problem. This type of maintenance program involves training maintenance personnel about the hazards of asbestos and about the procedures for keeping the asbestos from contaminating surrounding areas. Another function of an O&M program is to set up periodic visual inspections of all asbestos-containing building materials. Periodic inspections insure that if there is an exposure problem, it will be recognized and corrected before any major contamination occurs. This report does not recommend asbestos abatement actions that involve total immediate removal of the asbestos from the building. However, it should be emphasized that this is only a temporary solution based on immediate economics and exposure potential. Eventually, all of the asbestos-containing floor covering will have to be removed from this building to comply with paragraph 61.147 of the Environmental Protection Agency's regulations on National Emission Standards for Hazardous Air Pollutants (40 CFR Part 61), which requires removal of all friable or potentially friable asbestos materials (in excess of 260 linear feet or 160 square feet) prior to building demolition or major renovation that would disturb the material. The fact that the floor covering is not recommended for immediate removal does not indicate that it does not present exposure problems. It does suggest that there do not appear to be existing conditions resulting in a significant release of asbestos fibers to the atmosphere. However, any damage to the material (vandalism, water damage, accidental physical damage through maintenance activities, etc.) could result in significant fiber release.
